# ICC Decoder Module *Troubleshooting Guide*

This troubleshooting guide represents common field conditions and questions related to the ICC Decoder Module. Review the list of “Observed Field Conditions” in the table of contents below and then scroll to the corresponding page.

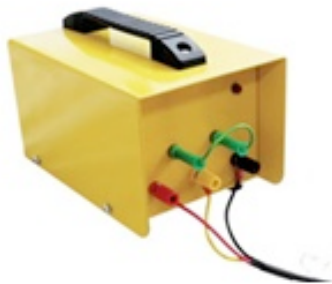
*Fault-finding transformer  
Underhill p/n TRANSFRMR-115V*

- 1) Confirm the ICC module has a #12 solid copper ground wire to a ground rod or ground plate. The ground rod should be a copper-clad 8” long x 5/8” diameter ground rod driven full-depth. Connect the ground wire without any sharp bends or angles. If local soil conditions prevent installation of a ground rod, consider using a ground plate. Both should be installed a minimum of 10’ away from the controller. Sometimes site conditions prevent this distance so shorter distances are acceptable as exception not the rule.
- 2) To troubleshoot the 2Wire path you will need the following troubleshooting equipment:
